# Audubon Assembly

### Creating Habitat in Unconventional Ways

# Corkscrew Swamp Sanctuary Ecosystem Restoration

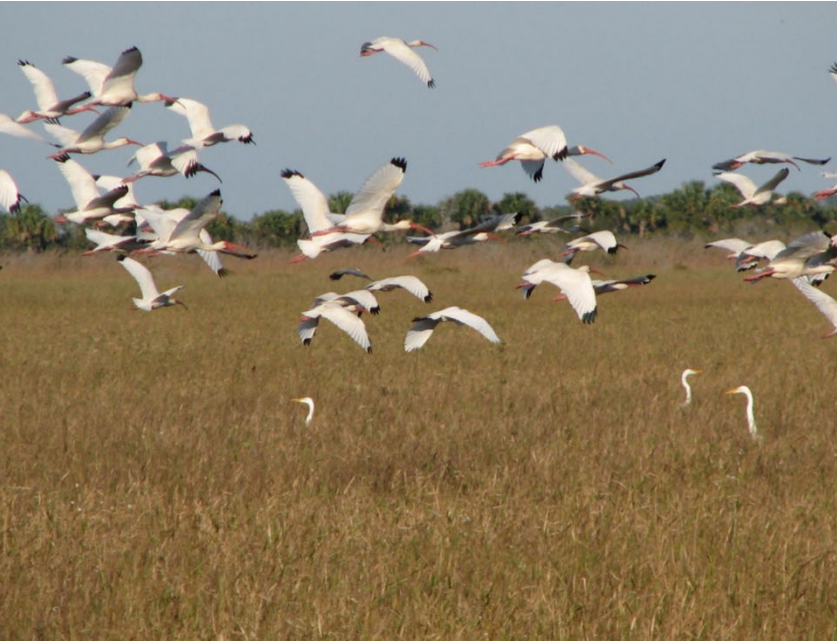
Freshwater Marsh

**29%**

2.6 months shorter

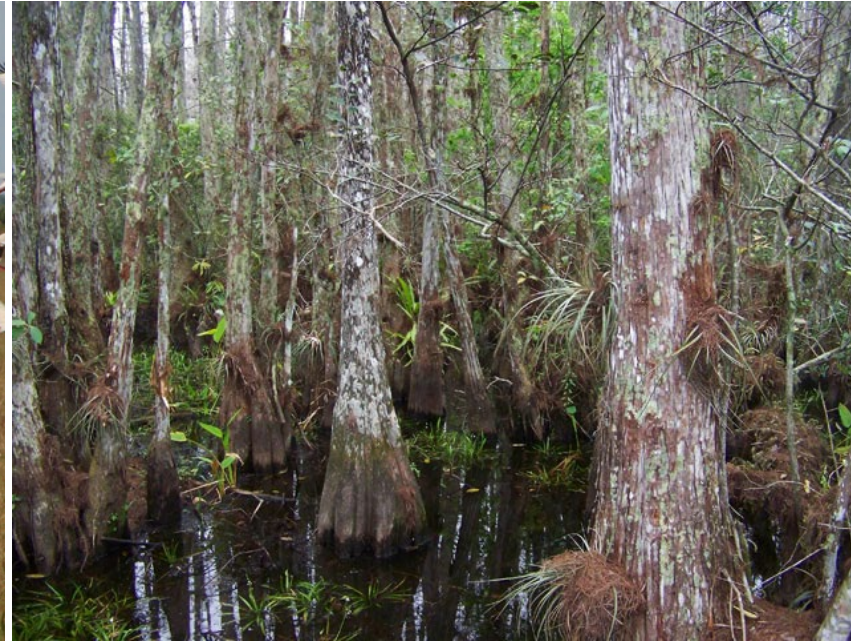
Bald Cypress

**18%**

1.9 months shorter

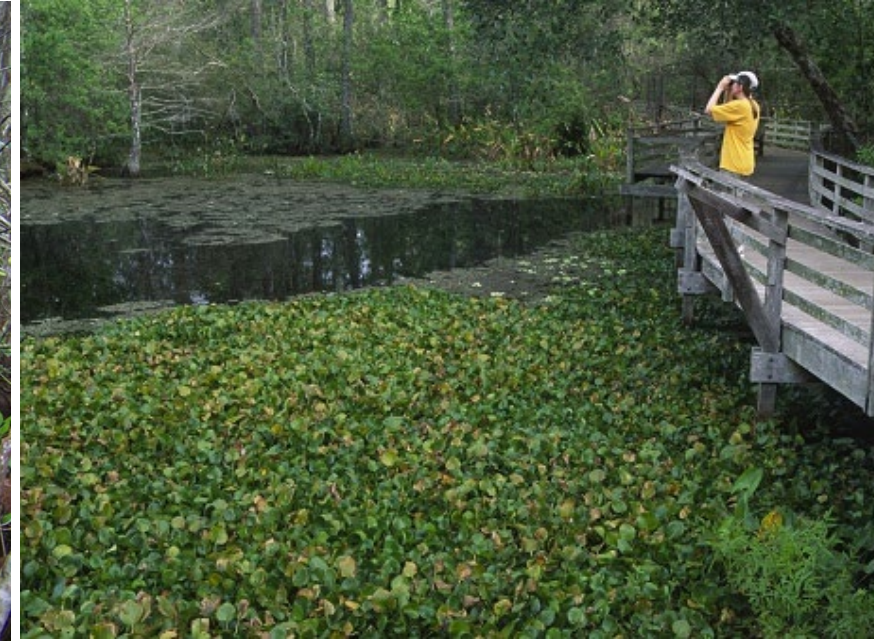
Pond

**17%**

2.0 months shorter

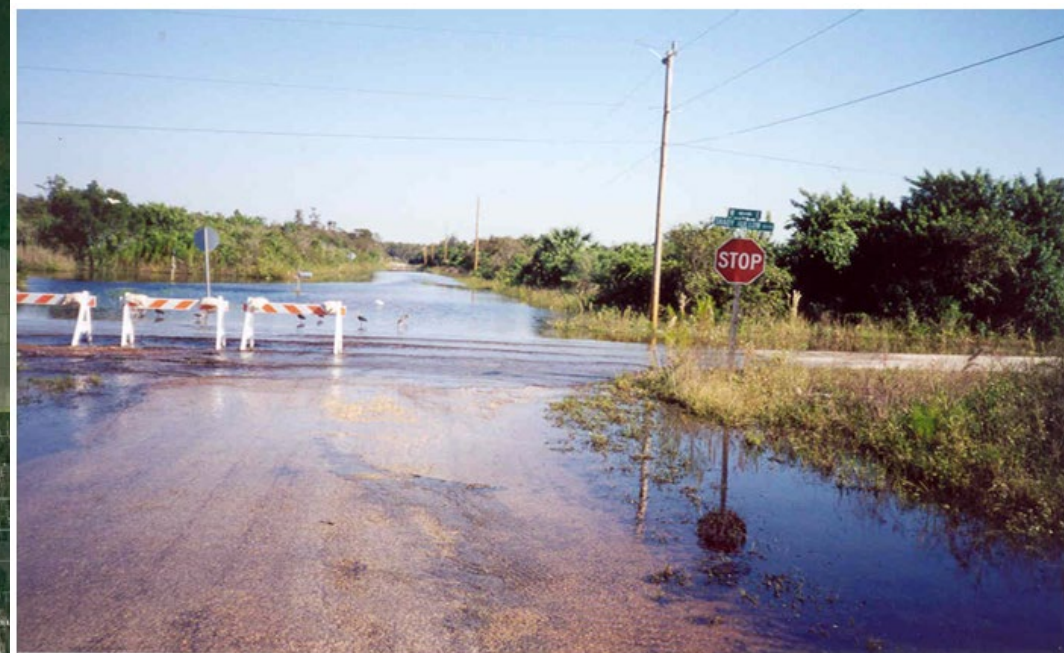
Figure 1a. Flooding from Corkscrew Canal on 43<sup>rd</sup> Ave., 2001
