Cowbone Marsh Restoration Plan

2a. Restoration Plan

2b. Onsite Restoration Activities

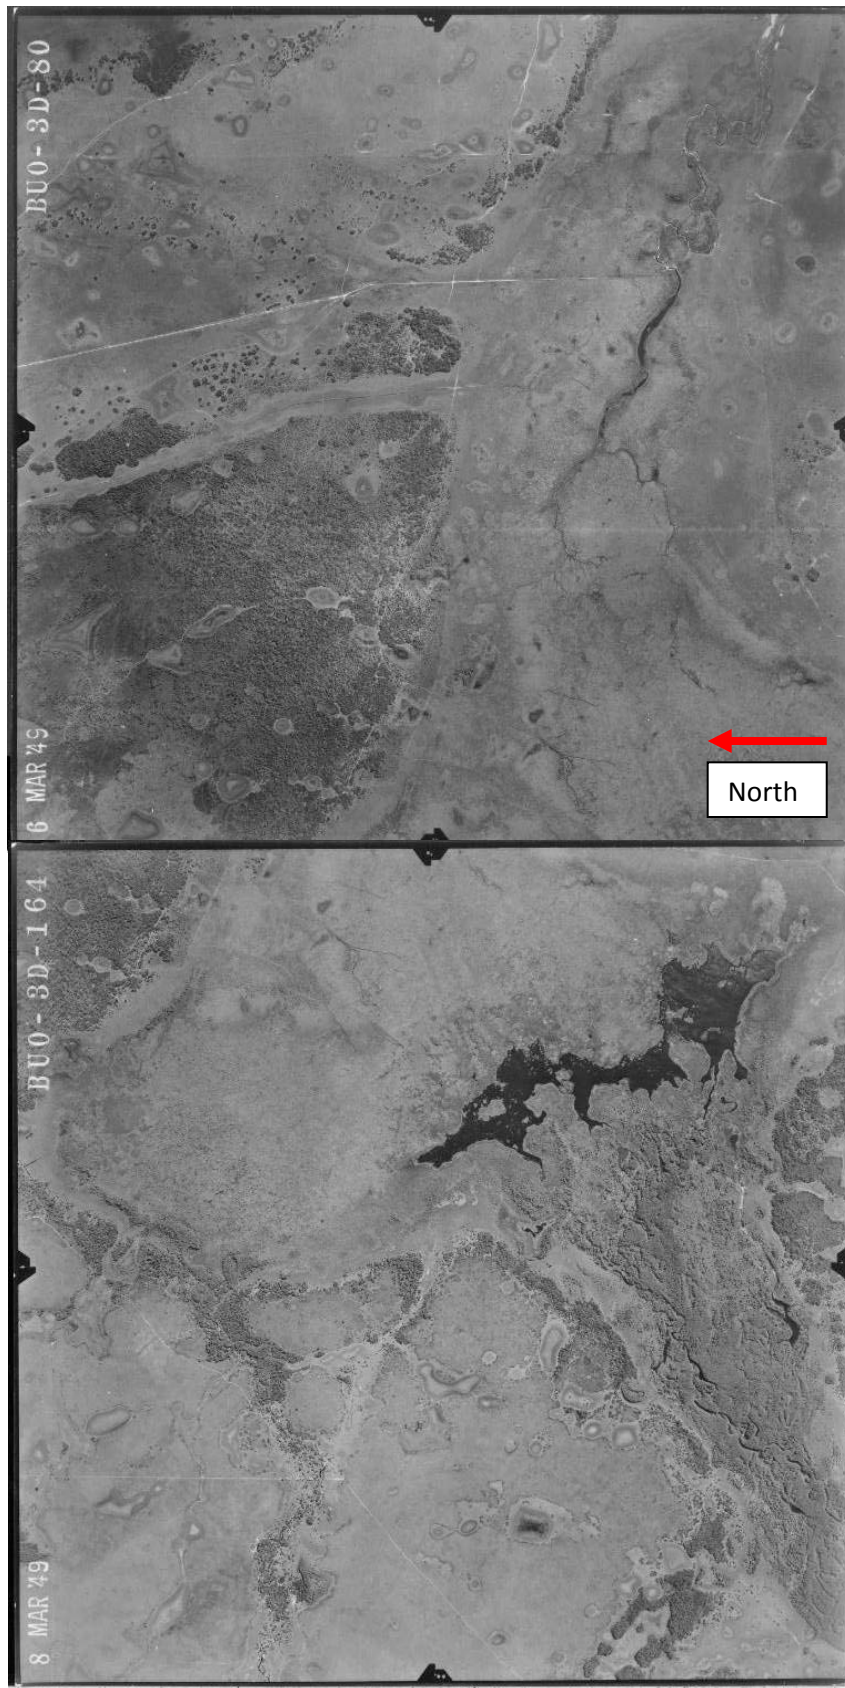
Exhibit 3 – 1949 Aerial of Cowbone Marsh open water areas

Aerials from the late 1940s depict large open water areas that dominated the lower third of the Marsh, just downstream of the cypress (see Exhibit 3). These large open water areas are estimated to have been approximately 150 acres in size, but have closed in over the succeeding 60 years, with the few remnant open areas totaling less than 15 acres (see Exhibit 4). There has also been a vegetation shift in the upper half of the Marsh, with willow (*Salix caroliniana*) now the predominant species in both those areas that were open water and those previously vegetated by herbaceous plants. Aerial photos also indicate linear canals were dredged within the Marsh, two of which are still discernable via current aerial photos and ground truthing. These historically dredged cuts have resulted in vegetation changes from that of the surrounding area. Although no research has been conducted to ascertain the cause of vegetation changes in these areas, it is consistent with changes in hydrology, most likely from drainage activities. Aerial photos also reveal a wide swath (~1,000 ft) of vegetative change resulting from an herbicide application conducted in the 1990's within the Marsh prior to state ownership (see Exhibit 5). The 1990s herbicide application has dramatically altered species composition within the affected area and is still clearly evident today.

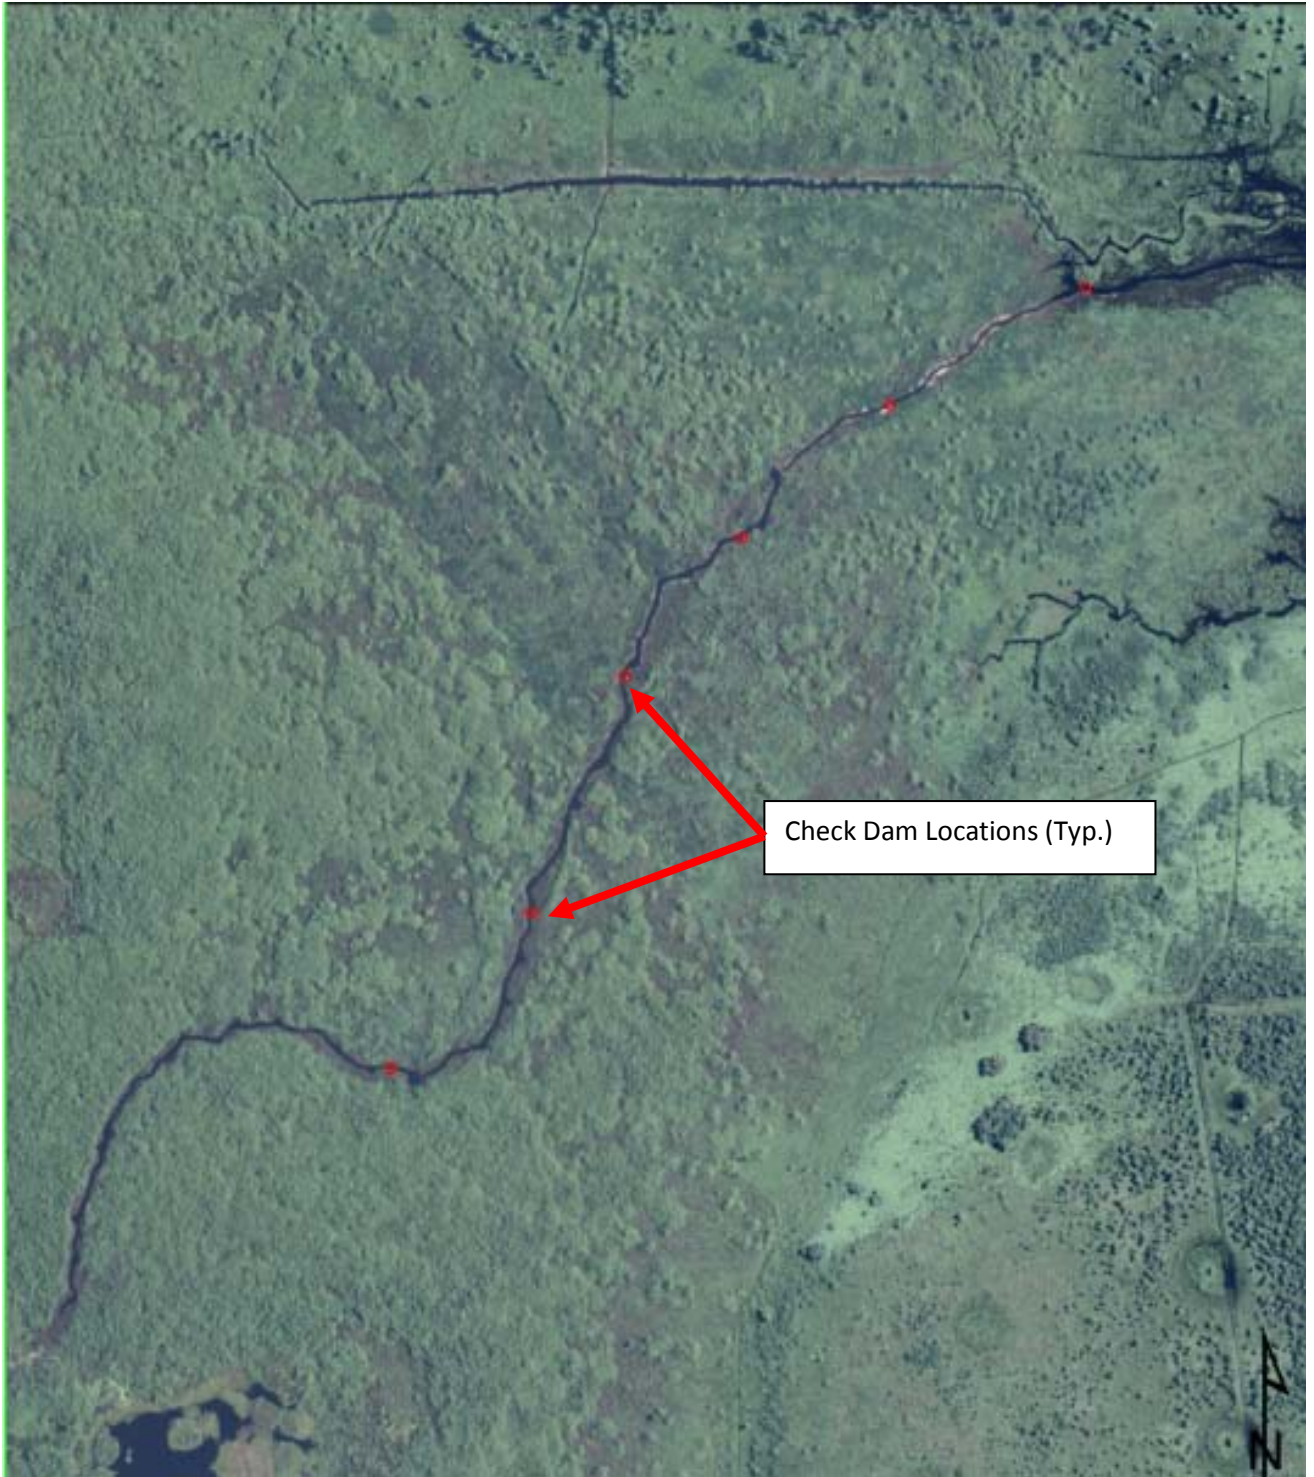
Exhibit 6 - Cowbone Marsh Check Dam Locations

These check dams are to be constructed of natural materials consisting of burlap sand bags, marine plywood, coconut matting, and palm trees (see Attachment 1). The check dams will be sloped to ease portaging of canoes and kayaks across them by the public. The six check dams will be spaced such that there will only be an approximately six-inch drop in the water levels across each dam. Based on a survey performed in 2010, the surface elevation drops 6 inches from the channel end to the existing weir structure and then drops an additional 32 inches from the weir to the channel mouth.

Therefore, the check dams will be installed at approximately equidistant intervals from the weir to the channel mouth (see Exhibit 6).

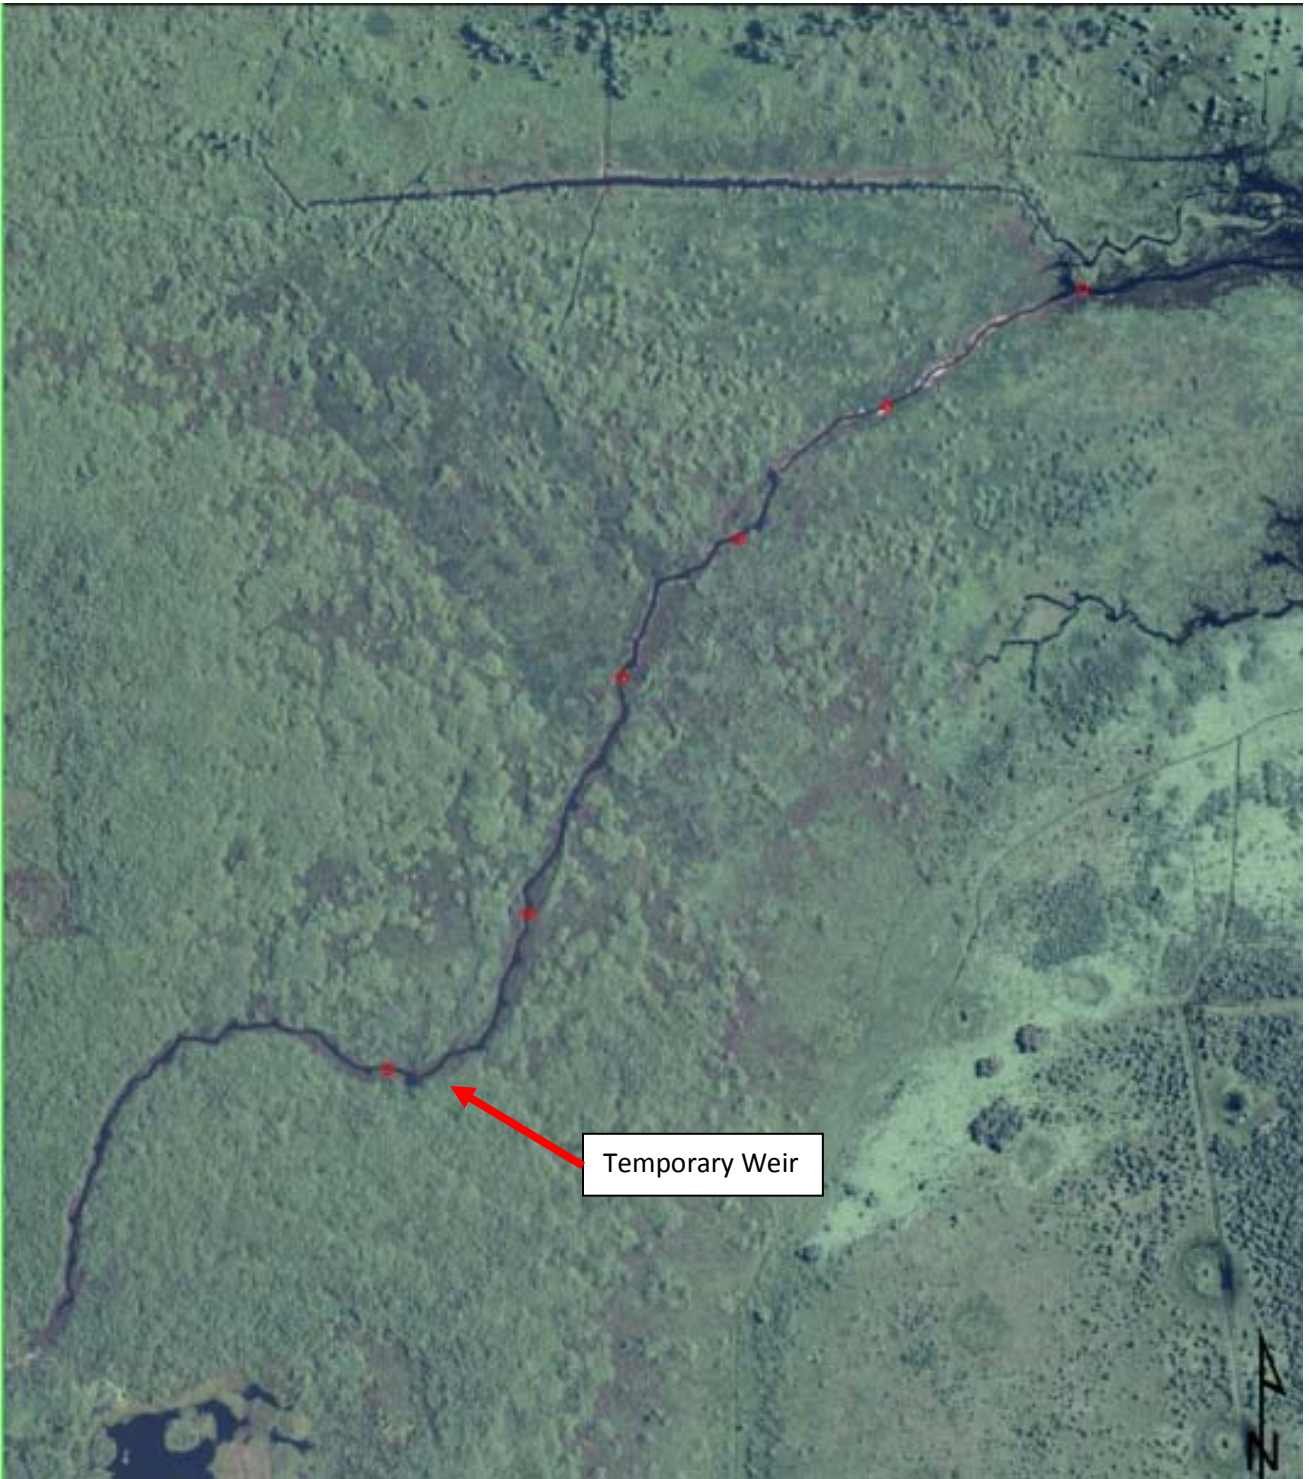
Exhibit 7 - Cowbone Marsh Temporary Weir Location

The temporary riser weir will be removed (see Exhibit 7). Though the structure was effective at restoring the upstream hydrology and providing safe passage across the weir for watercraft, it did not meet the requirements of using only natural materials that would break down over time. Therefore, the riser weir will be removed during the construction phase of the check dams once it is no longer needed.

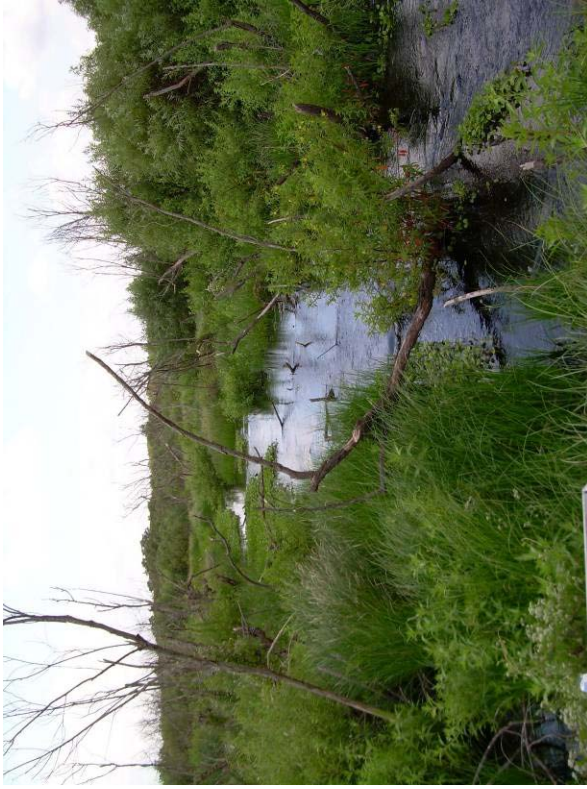
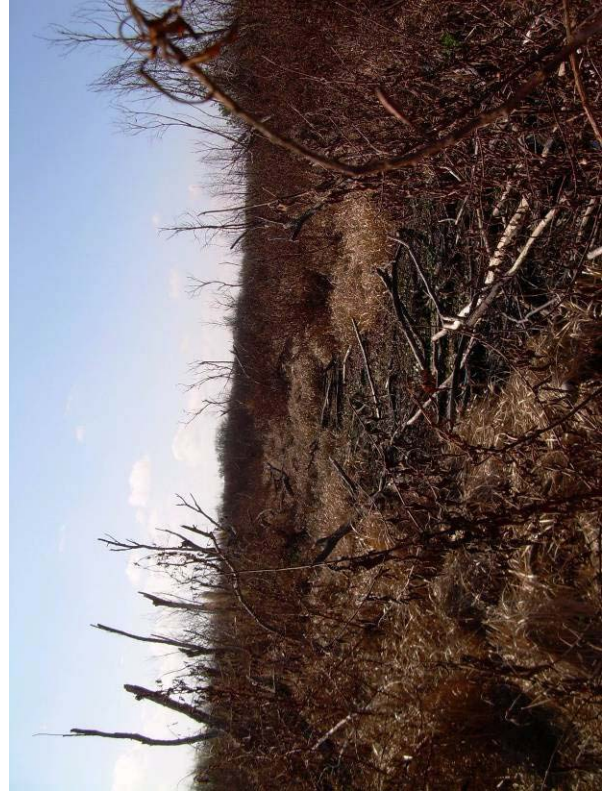
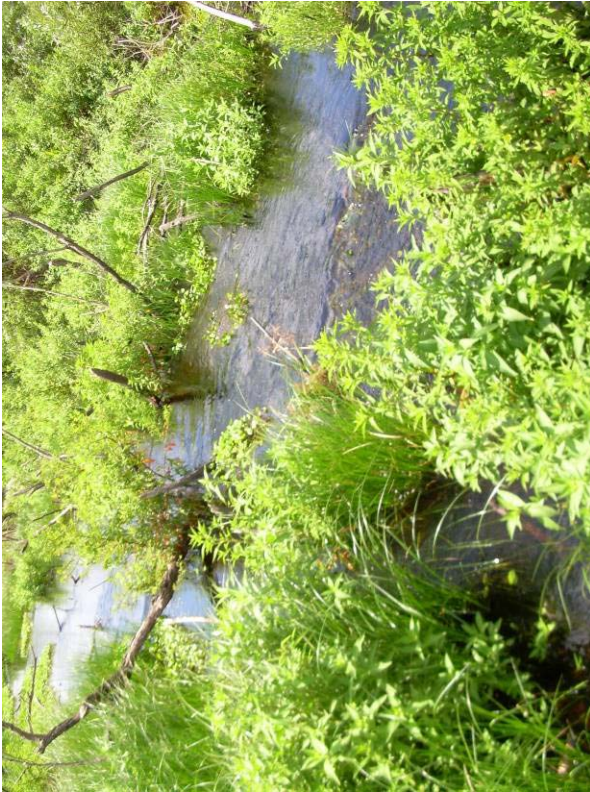
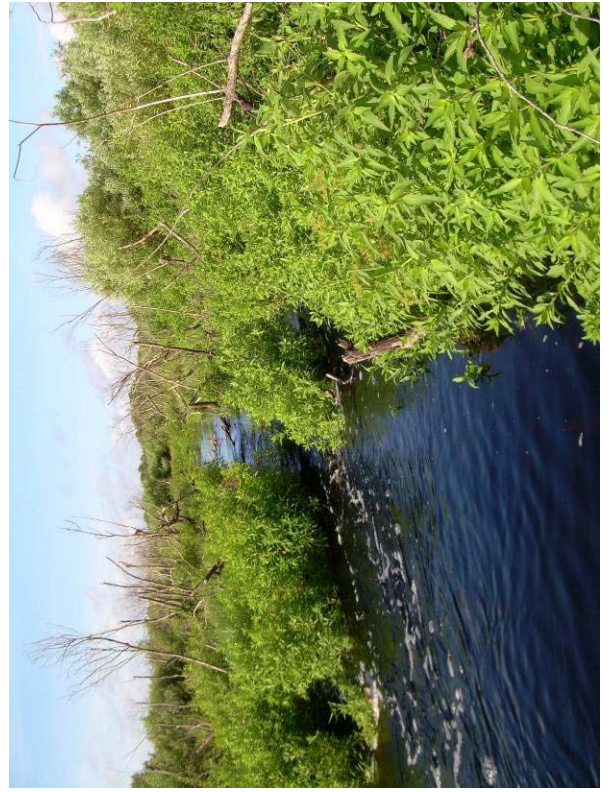
Exhibit 8.1 - Cowbone Marsh Vegetation Photos

Following are pictures of both the east portion and west portion of the trail vegetation, as well as some pictures from Summer 2010 on the east portion near the end of the cut (see Exhibits 8.1 and 8.2). The identification of the miscellaneous grasses, sedges, and ferns from the summer pictures are undetermined since most of them are taken from too far away.

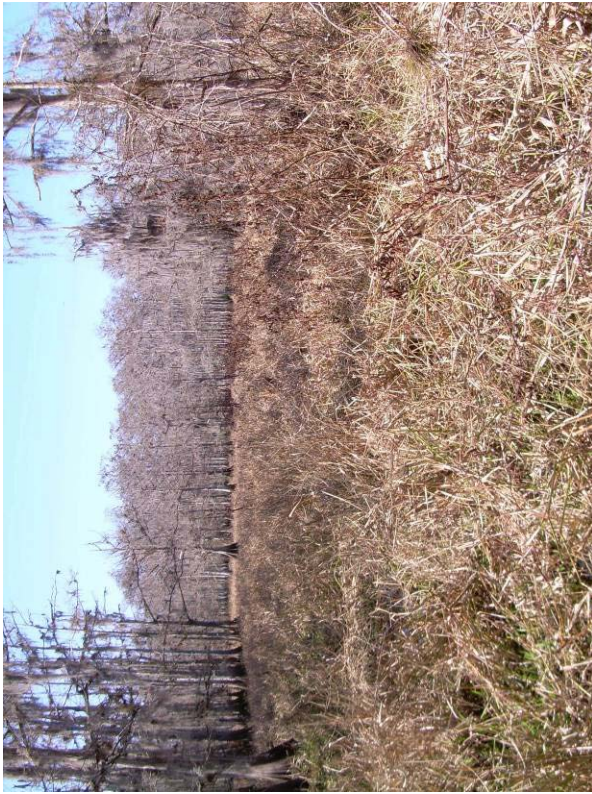
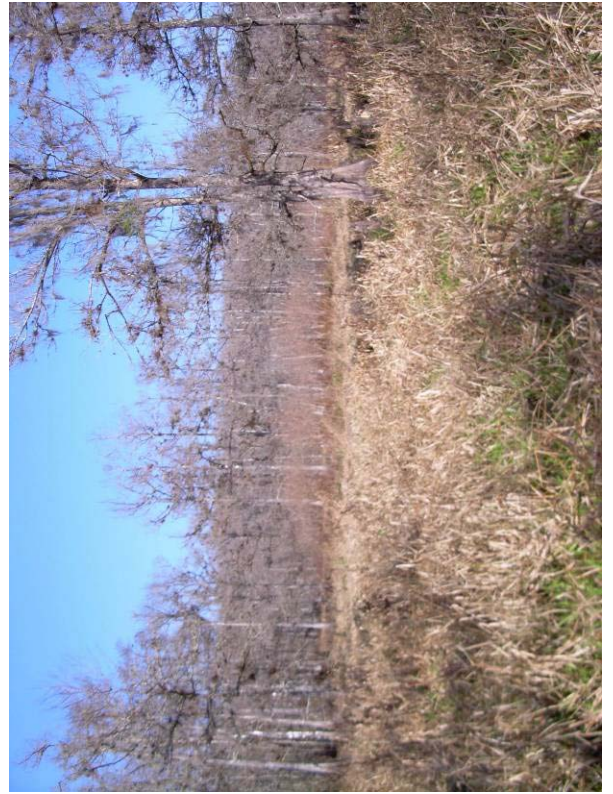
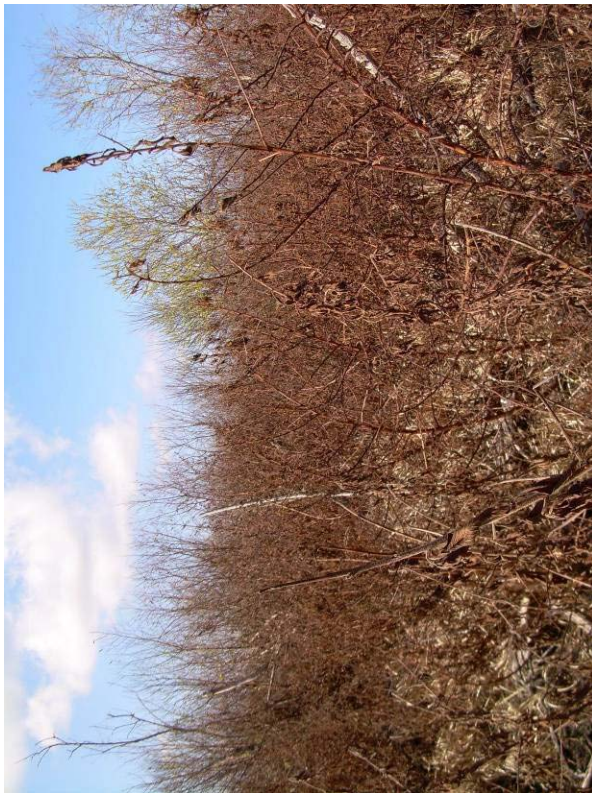
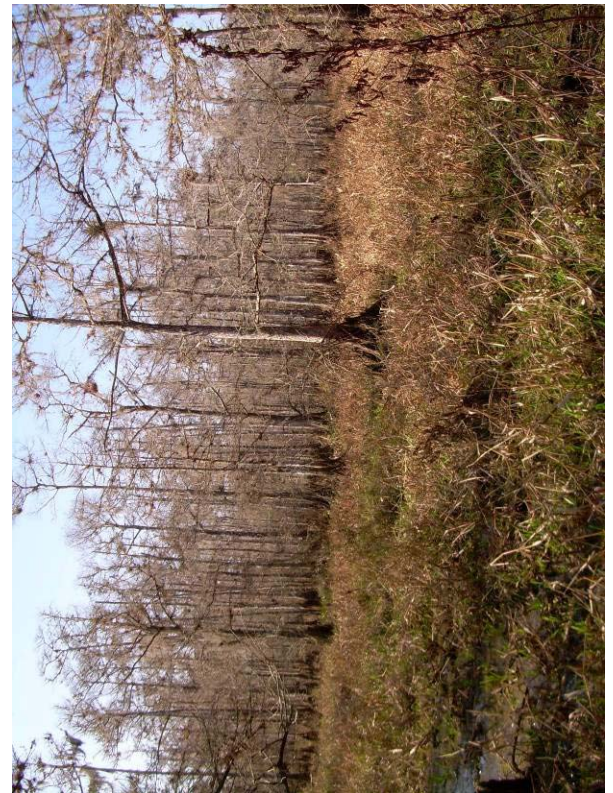
Exhibit 8.2 - Cowbone Marsh Vegetation Photos
